Best Practice Sporting Fields

A guide for turf surfaces in the Lower Hunter

Book 1: Defining Best Practice

Published by Hunter Water

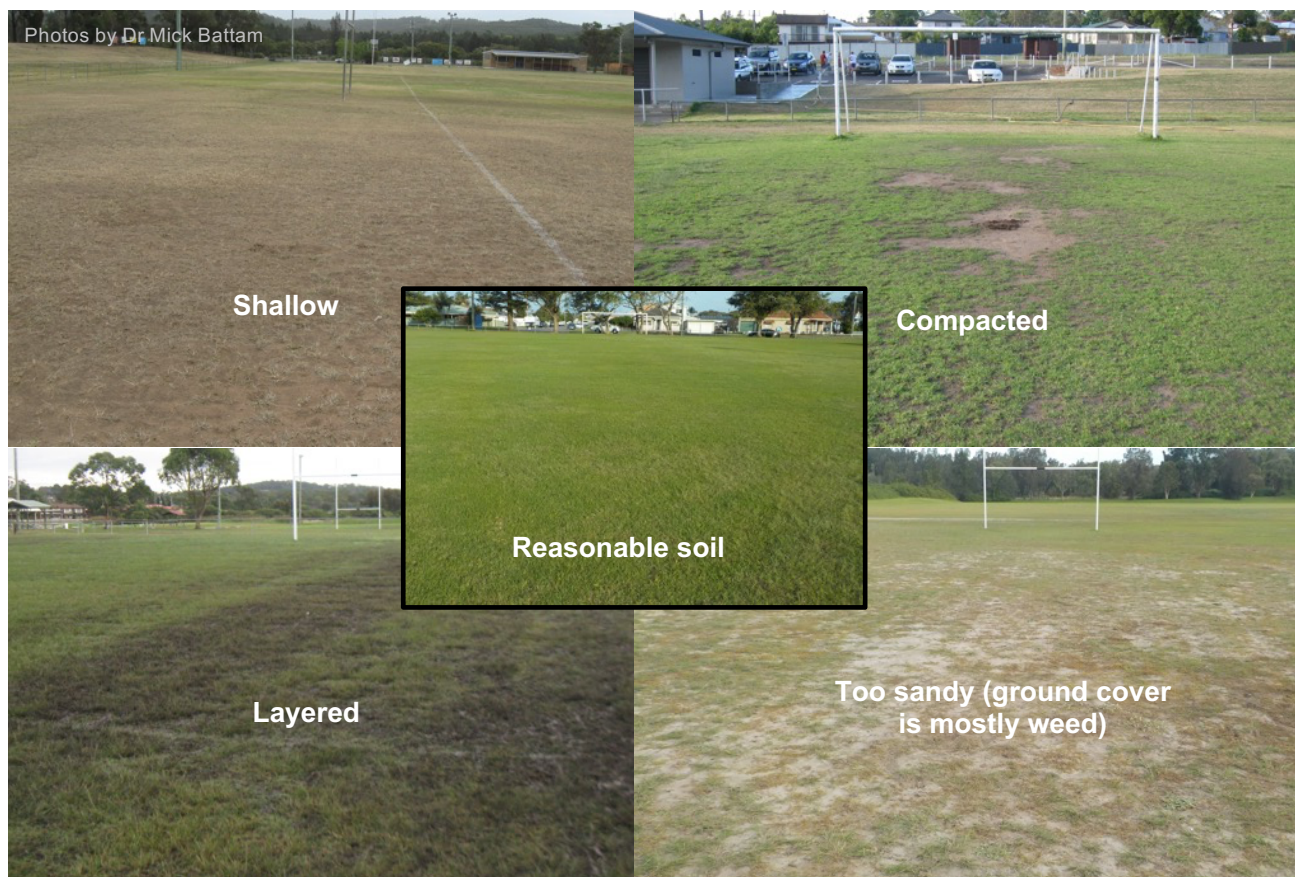
Figure E1: The impact of soil on the performance of five kikuyu fields. All fields receive low levels of wear, similar applications of fertilisers and none of the sites have an automatic irrigation system.

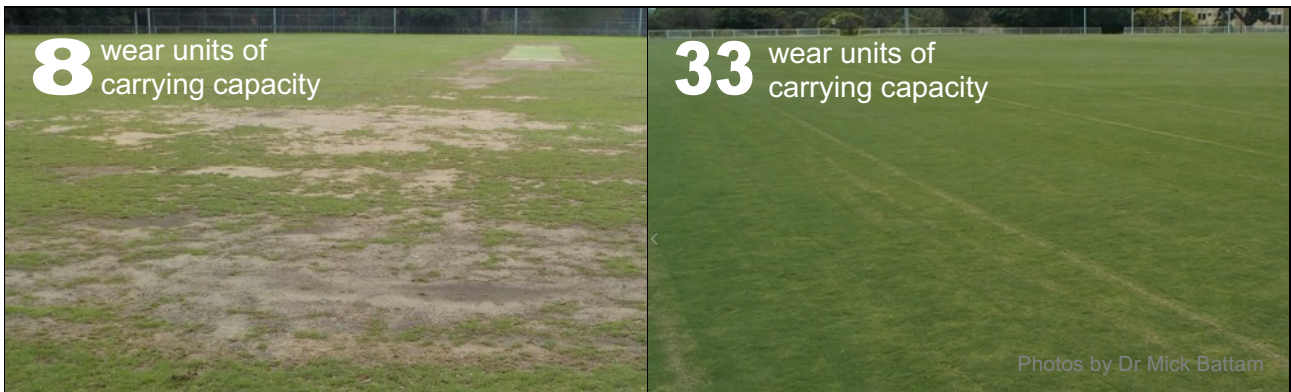
Figure E.2: Even though these two fields have the same turf cultivar, their carrying capacities differ greatly.

- booked hours significantly overstate usage hours (clubs overbook to “reserve” their field)
- booked hours are not related to wear levels (sport code, player ages, player numbers, etc.)
- carrying capacity is not a single number and varies widely between sites (Figure E.2).

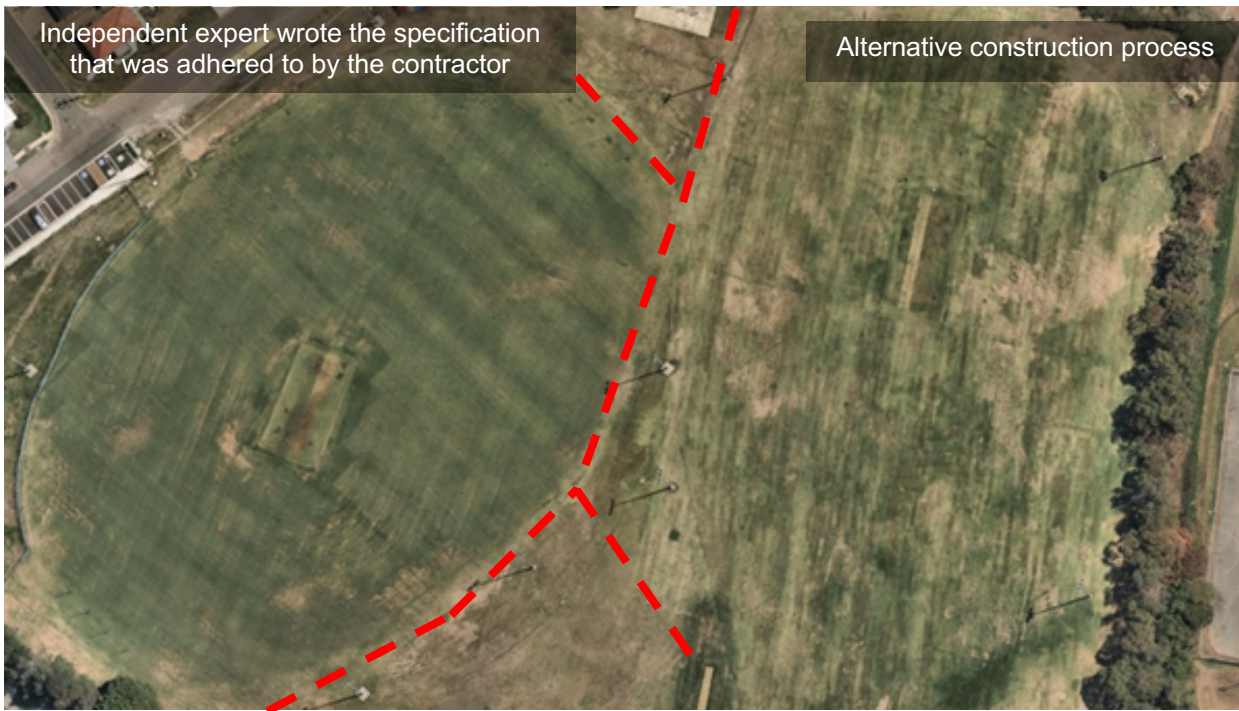
Figure E.3: Contrasting outcomes of two methodologies used to construct adjacent fields. The field on the left was rebuilt first according to best practice and performed above expectations. The field on the left has a superior playing surface, and 70% more carrying capacity during drought (Nearmaps image).

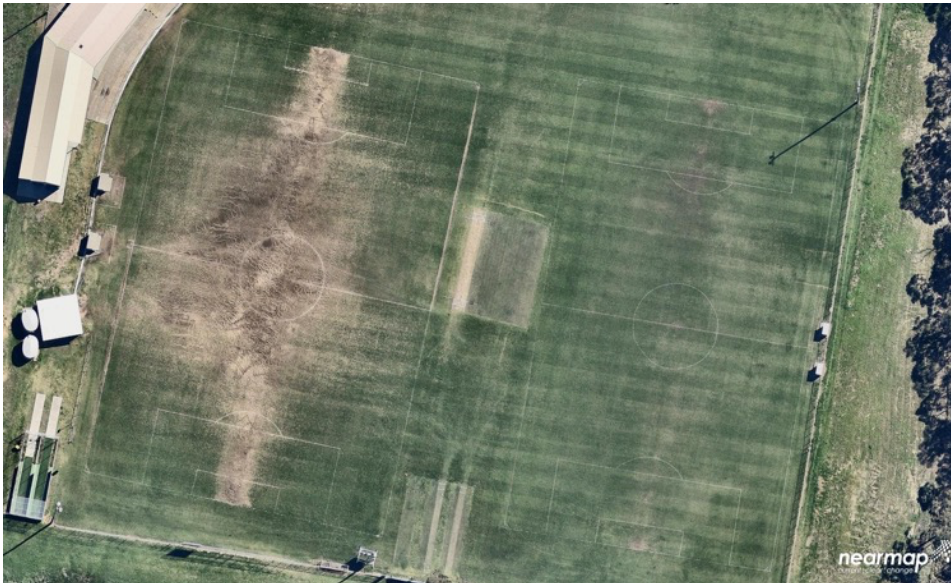
Figure E.4: The club would have a better playing surface if wear was spread more evenly at this site. This could be achieved by undertaking more training on the field used less on game day (Nearmaps image)

Users and clubs can dramatically improve the condition of their sporting fields by spreading wear more evenly (Figure E.4), cleaning out drains, hand chipping weeds and performing repairs to worn areas at the end of the football season. Council may lack the labour force to perform these tasks.

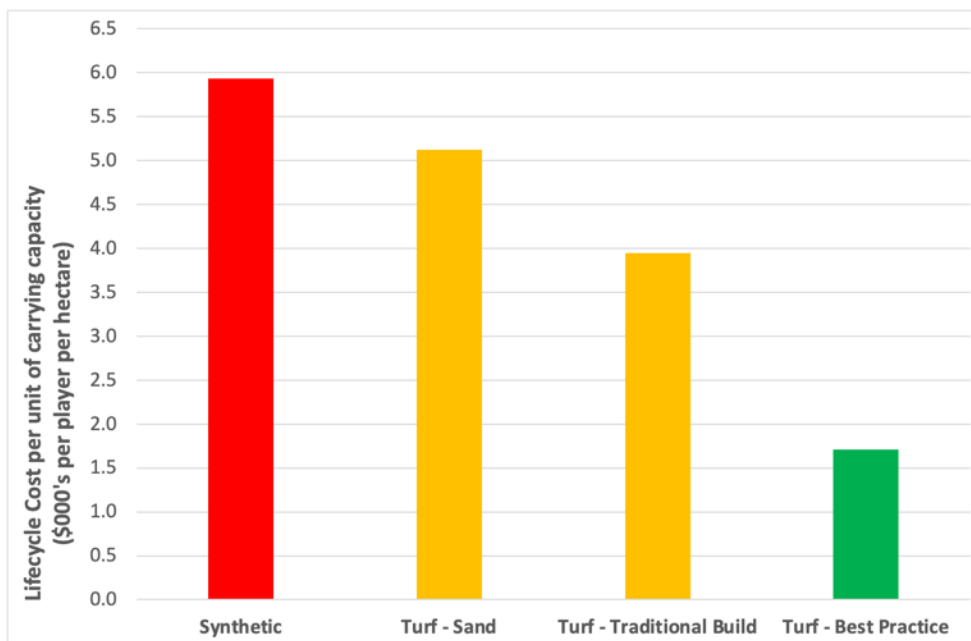
Figure E.5: Lifecycle costs per unit of carrying capacity for different types of field construction

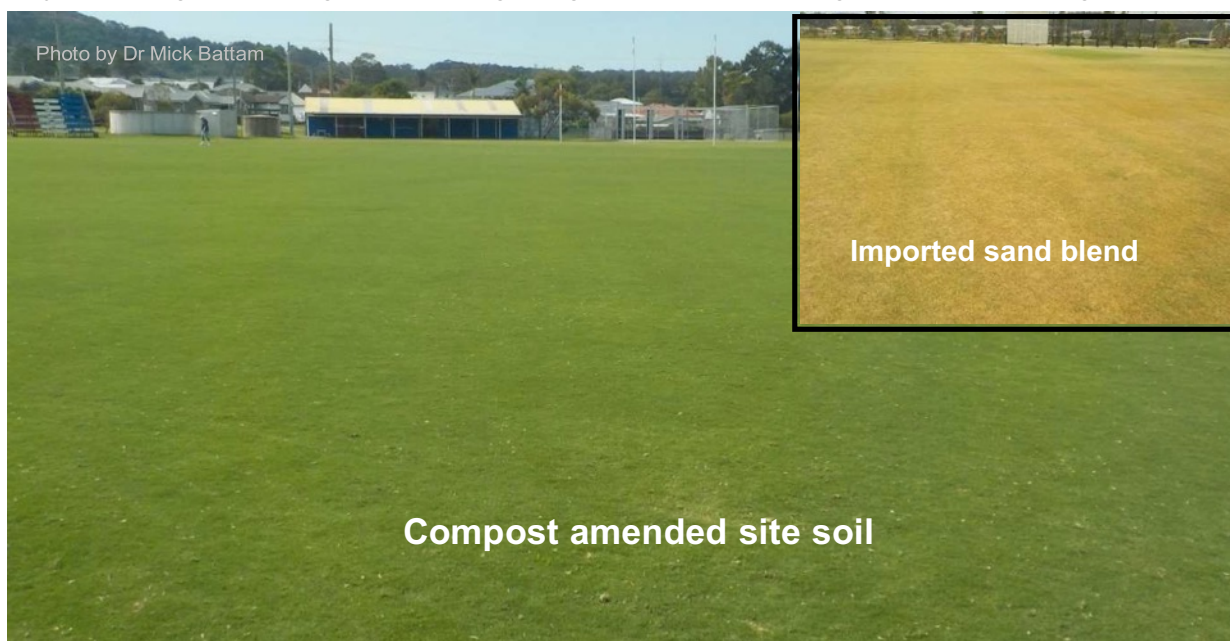
Figure 1.4: Despite having the same turf cultivar, these two irrigated fields performed very differently during the level 1 water restrictions due to important differences in soil type and preparation. Apart from requiring more water, the imported sand field poses a risk to council and the site users as it might struggle to even survive during level 2 or level 3 water restrictions.

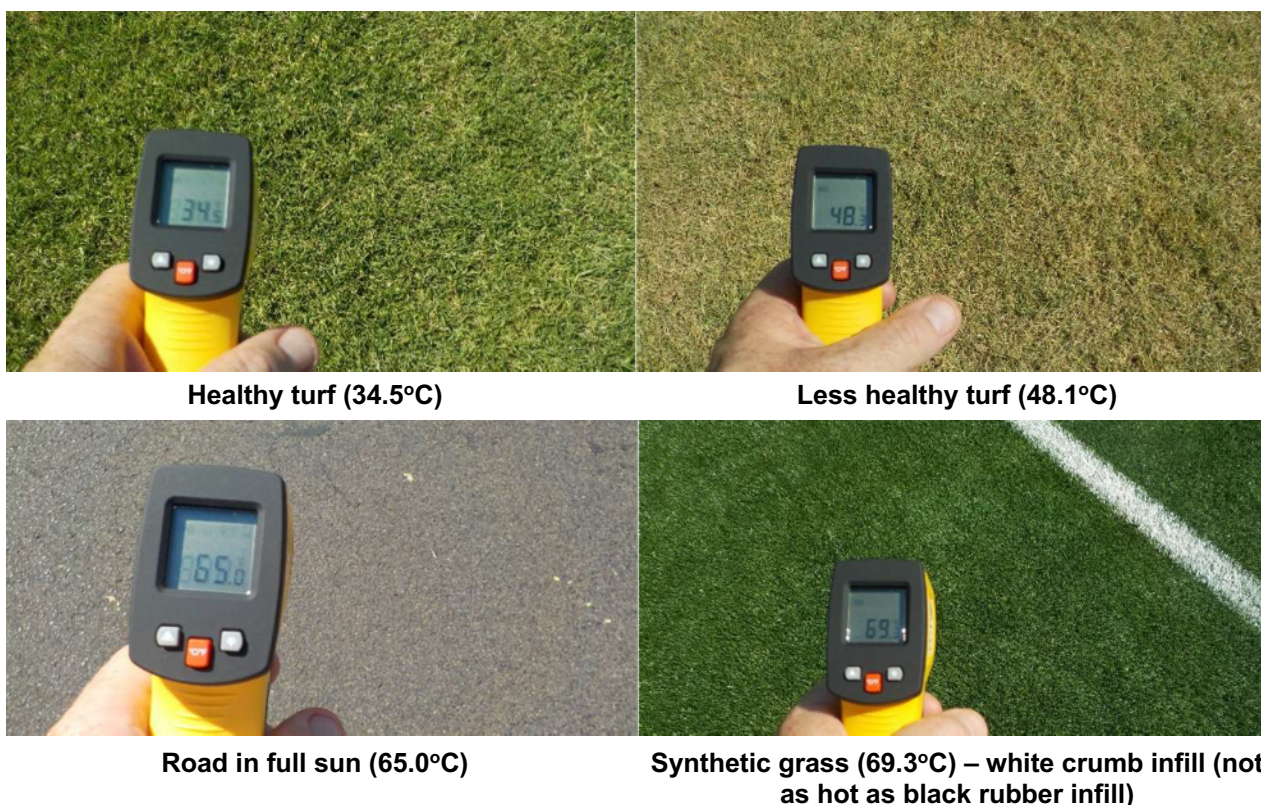
Figure 1.5: In addition to removing carbon dioxide from the atmosphere, natural turf can play a key role in combatting urban heat islands as shown by these temperatures taken on a 38°C day.

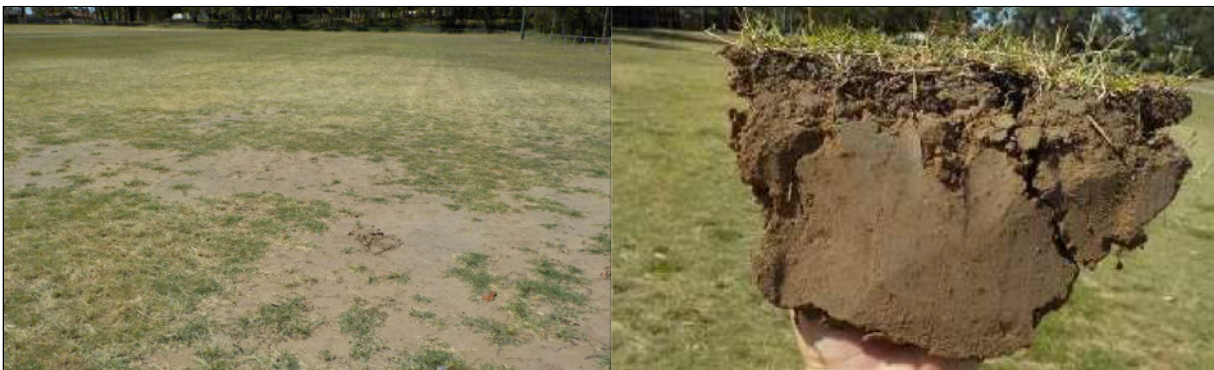
Figure 2.1: A third drop Clegg hammer reading of less than 120 is required for safe play on local sporting fields (Table 3.1). However, this field had readings ranging from 220 to 430, with the bitumen road having a value of 600. The incorporation of large quantities of organic matter is needed to address the hardsetting nature of many of the soils in the Lower Hunter. The reasons why soils in the Lower Hunter set hard are outlined in Book 2.

Whilst large areas of bare ground were observed on a few sites (Figure 2.1), weeds were generally the reason for poor cover. Common weeds in the Lower Hunter and their control are discussed in Book 7.

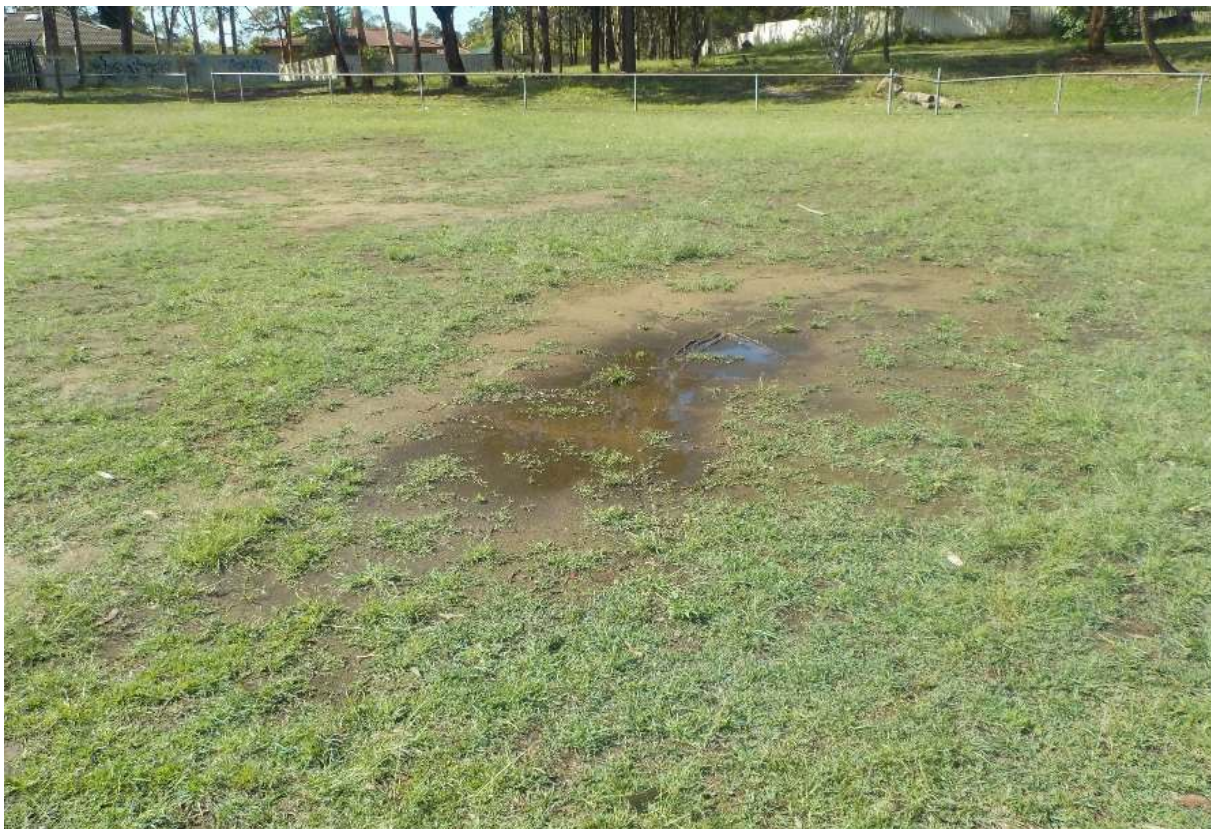
Figure 2.2: Water lying in a depression due to a combination of compaction and unevenness, with the rest of the field relatively dry.

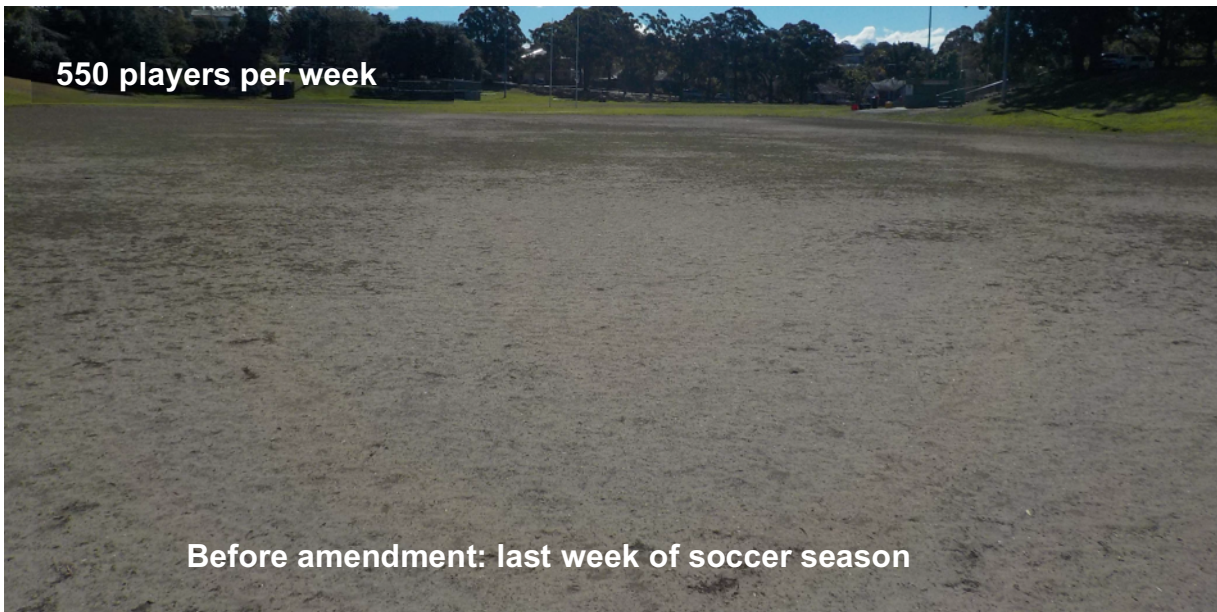
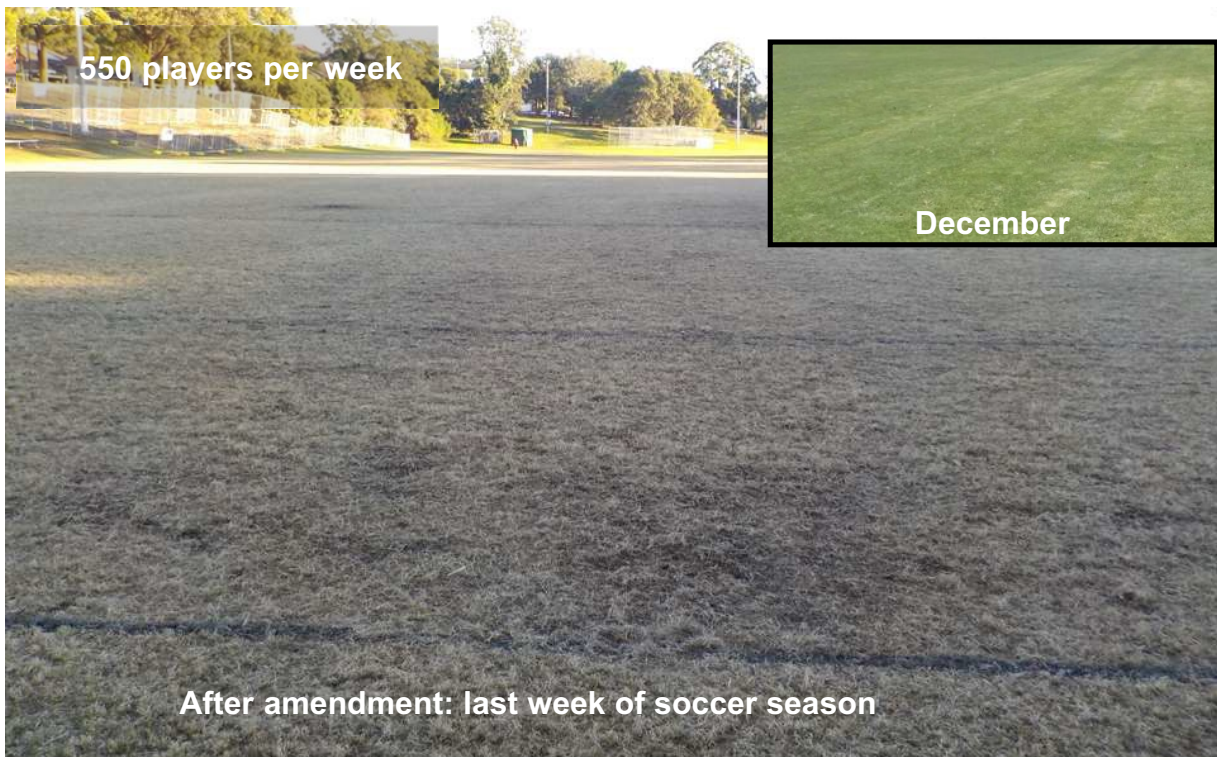
Figure 2.4: Sporting field that was previously a dust bowl (upper). It was rebuilt according to best practice (lower) and now handles 550 players per week and recovers without turf patching (insert). Whilst the turf is dull and thin by the end of the soccer season, it remains functional as a local field and rapidly recovers (insert). This site receives more intense wear than any field in the Lower Hunter and would perform even better if more fertiliser was applied and other measures were implemented.

These findings are consistent with the performance of sporting fields in other areas that have been constructed and maintained according to best practice and handle high levels of wear (Figure 2.4).

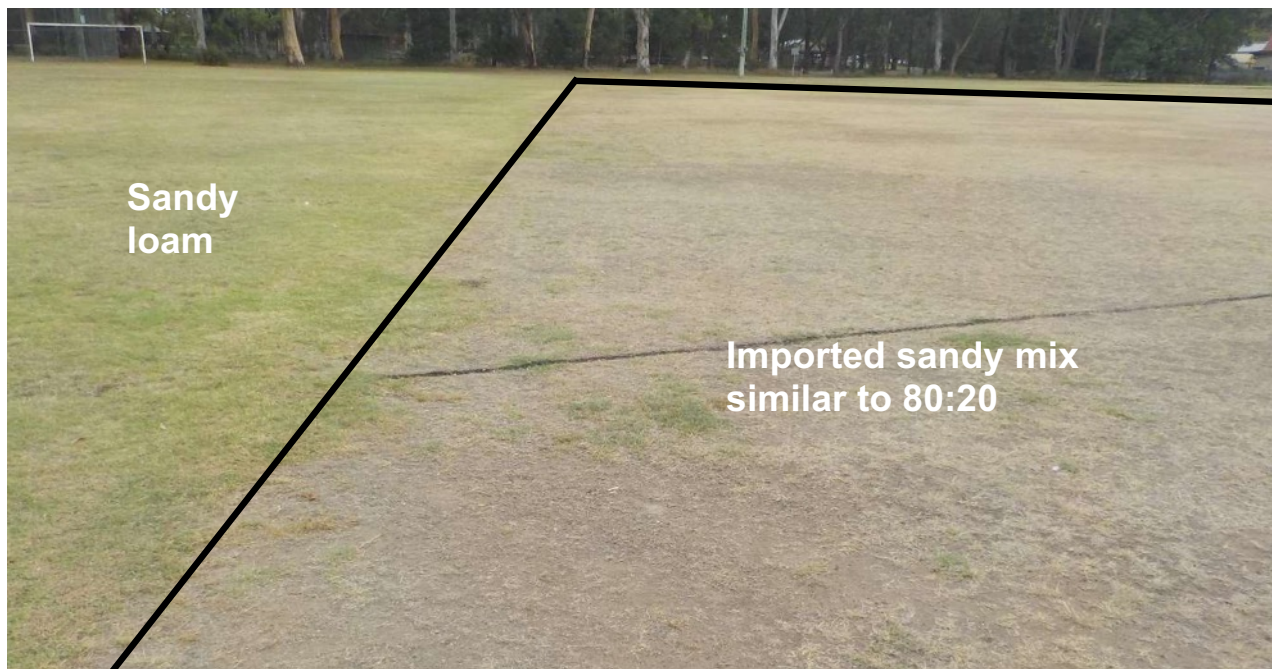
Figure 2.5: An imported sandy mix was used to construct a football field in the centre of Edgeworth athletics field. This soil is so poor that almost all the turf has died, with the adjacent sandy loam area (natural soil) performing reasonably well in January 2020 despite receiving no irrigation and only 6 mm of rain in the 70 days prior to this photo being taken.

In contrast, fields constructed with soils that have a low water holding capacity typically struggle in dry periods, even when they are watered twice a week (Figure 3.3). If unirrigated fields are constructed with sand-based mixes, then they may almost completely die off in dry periods (Figure 2.5).

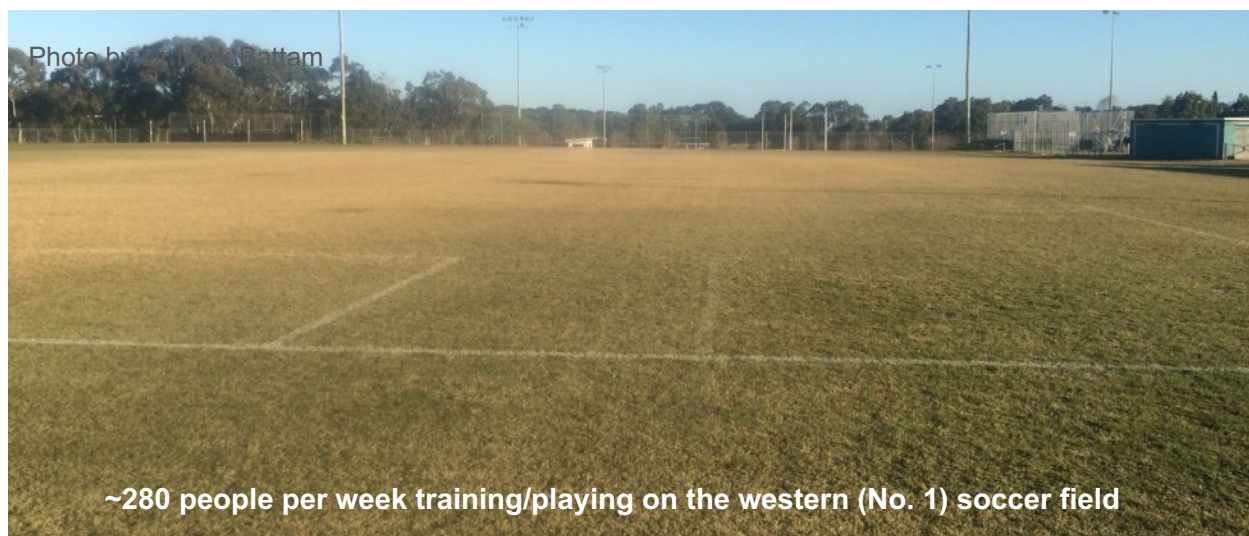
Figure 3.1: Despite receiving more wear than 92% of sporting fields in the Lower Hunter, Kahibah Oval no.1 soccer field maintains good cover even at the end of the soccer season. As such, if all fields in the Lower Hunter were built and maintained according to best practice then most of the irrigated fields should look no worse than Kahibah Oval. Photo taken in August at the end of the soccer season. The works at Kahibah Oval are still not complete, with the site requiring a drain to prevent water running onto the field and a closely spaced slit drainage system that is not required on many other sites.

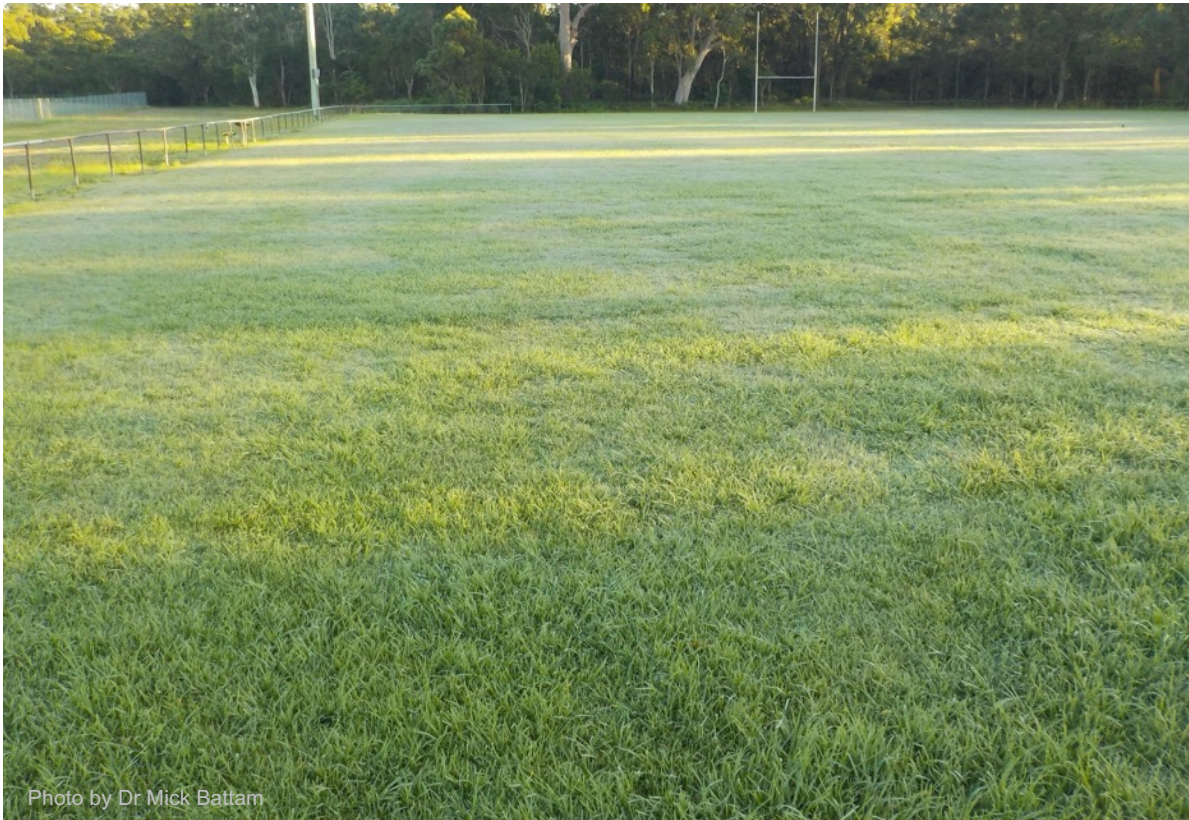
Figure 3.2: Despite not having an automatic irrigation system, Keith Barry No. 2 field at Toronto easily survived the 2019/2020 summer when less than 6 mm of rain fell over a 70-day period. Due to water restrictions limited irrigation was permitted in the centre corridor during this period, with this photo taken 3 months later.

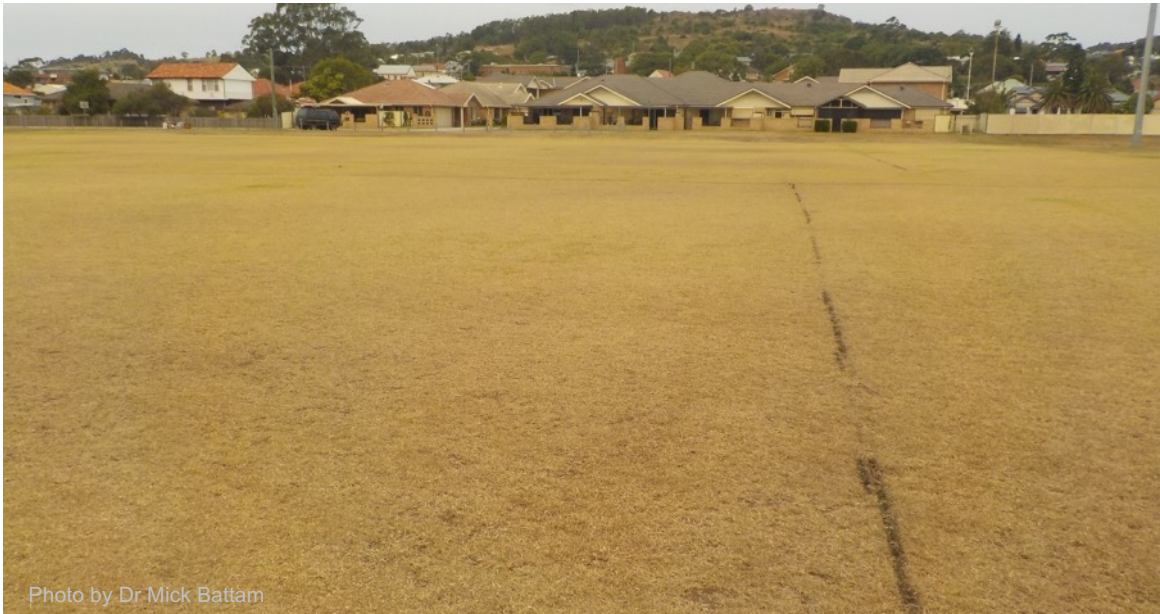
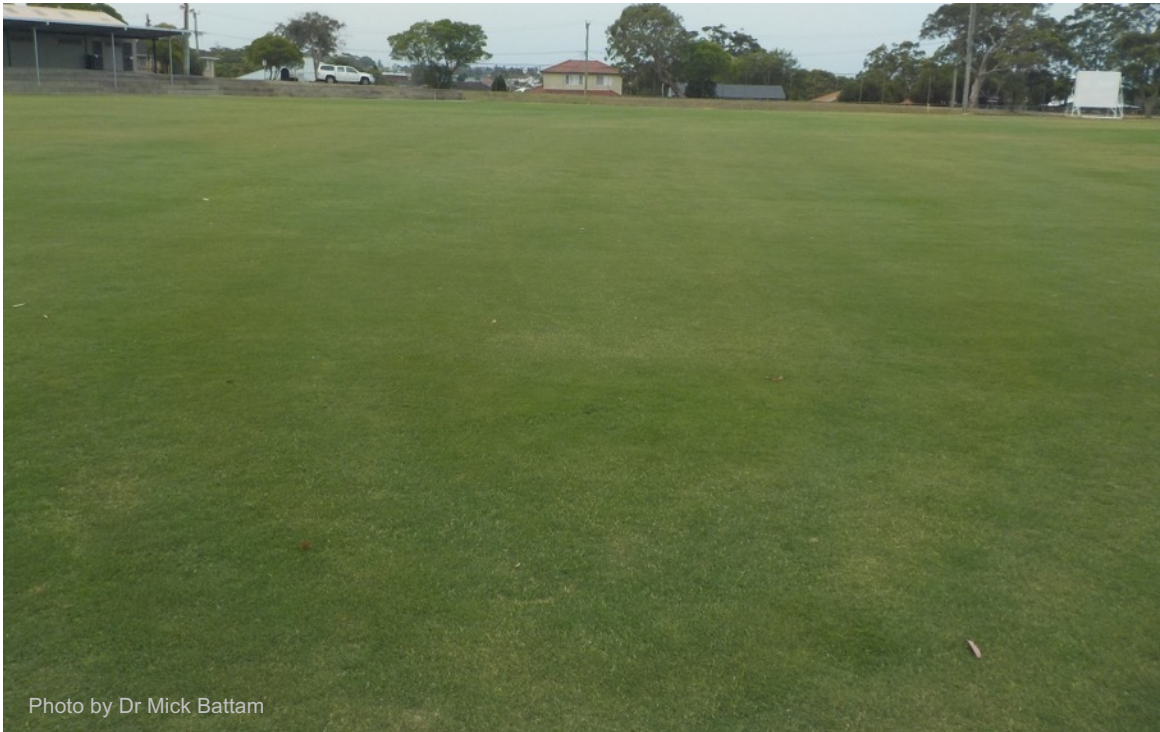
Figure 3.3: These fields performed very differently in the 2019/2020 drought even though both were being watered twice a week. The turf in the upper picture would likely have not survived had level 2 restrictions been implemented earlier during the drought.

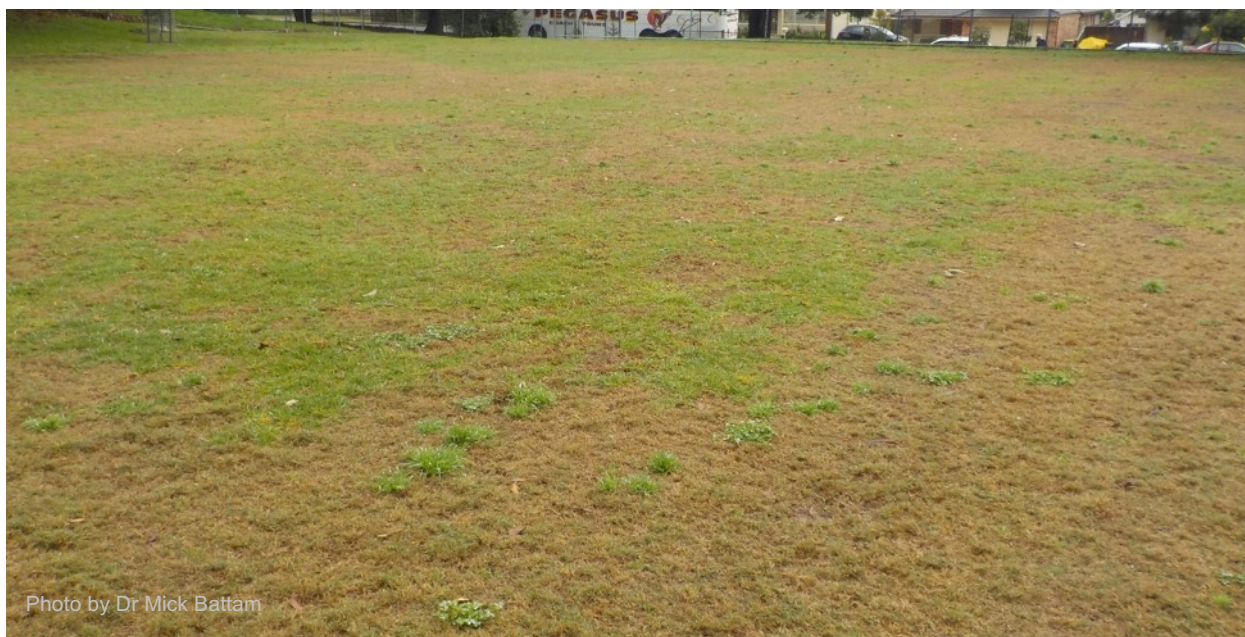
Figure 3.4: High wear sporting field that was rebuilt according to best practice and performed well for 3 years. However, due to limited weed control, a less wear tolerant turf species is spreading across the field. This will greatly reduce the carrying capacity of this field.

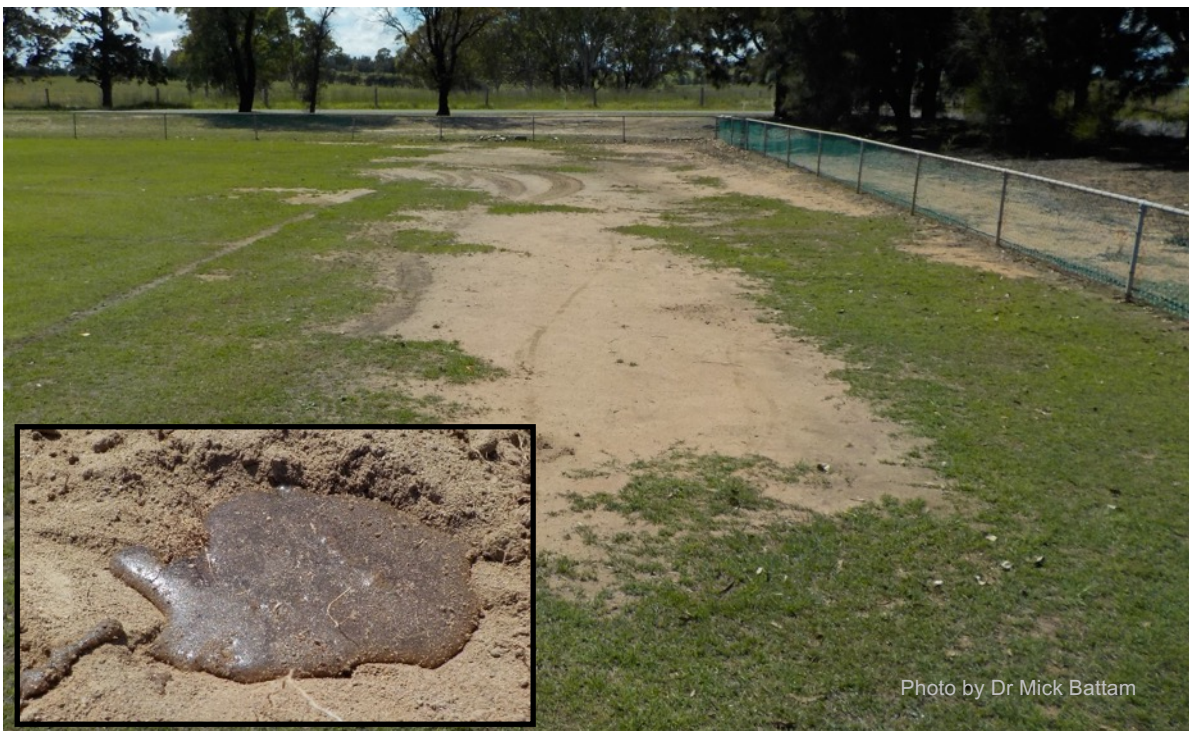
Best practice involves addressing the underlying cause(s) of the problem so it does not reoccur in the future. For example, a site covered in weeds may benefit from the application of an appropriate herbicide, but this will only address the symptoms if the turf continues to remain thin due to other issues (Figure 3.5).
